**CASE STUDY:**  
Replacement of valve using Pipe Freezing Service

## Case Study: Repair pipe leakage using Pipe Freezing Service

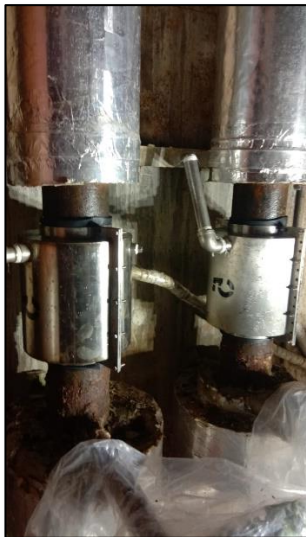
Installation of pipe freezing jacket at proposed location

First, out specialists conducted the non-destructive Ultrasonic flow measurement test. Once we found there is no water flow in that section of pipeline, we start install the pipe freezing clamp at the proposed location and connect it to Nitrogen cylinders.

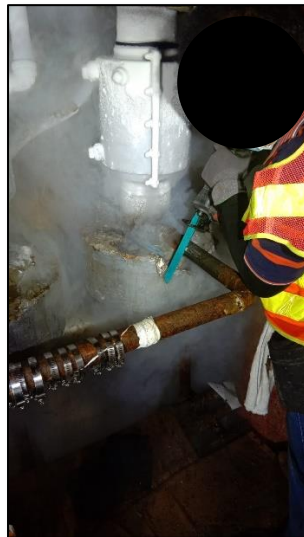
Pipe Freezing at proposed location

Our specialists will continuously monitor the temperature profile in entire pipe freezing process, when the temperature profile decrease to the acceptable level and confirmed the ice-plug was formed successfully, our specialists will pass to client to carry out the following hot work and pipe replacement work.

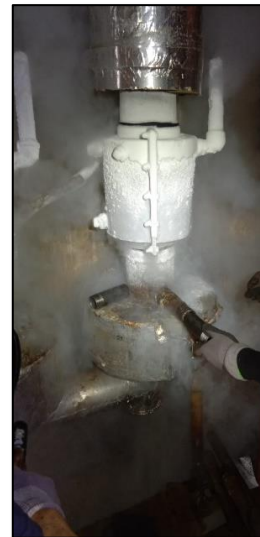
Finish the pipe freezing work

While the replacement work was done, our specialist will remove the pipe freezing clamp and let the ice plug defrost by natural. Then, the pipe replacement work was well completed in short length of time and Alstern Technologies remain the is still incomparable as one of experienced pipe freezing companies in the Asia Pacific region.
